# **Case-Study Analysis**

## **Findings of Summary Vulnerability Assessment**

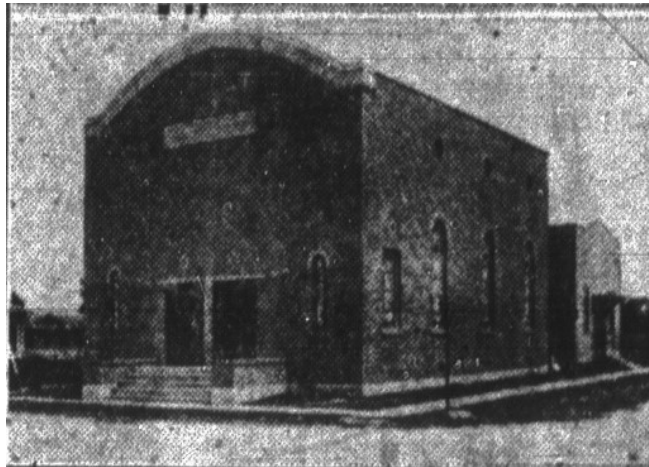
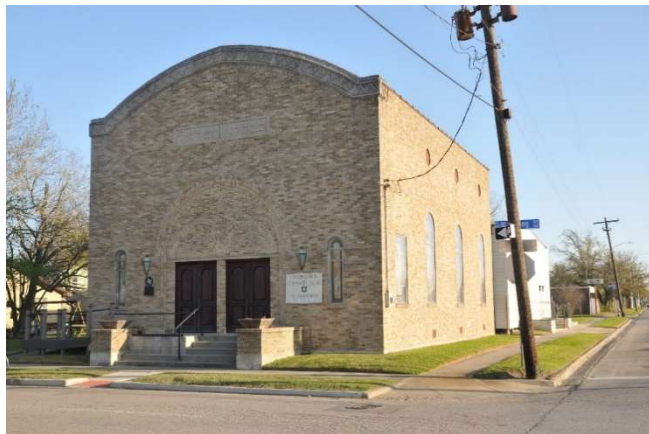
**Figures 5.01 and 5.02:** K'nesseth Israel Synagogue viewed from the south in 1933 and present day.

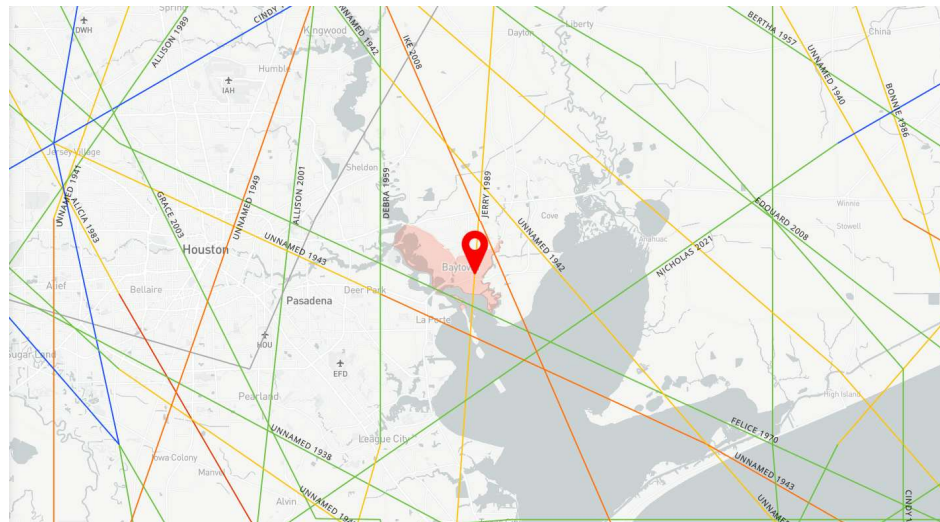
**Figure 5.04:** Paths of storms since 1930 (NOAA). The lines represent the centerline of each storm, although the effects are typically very widespread.

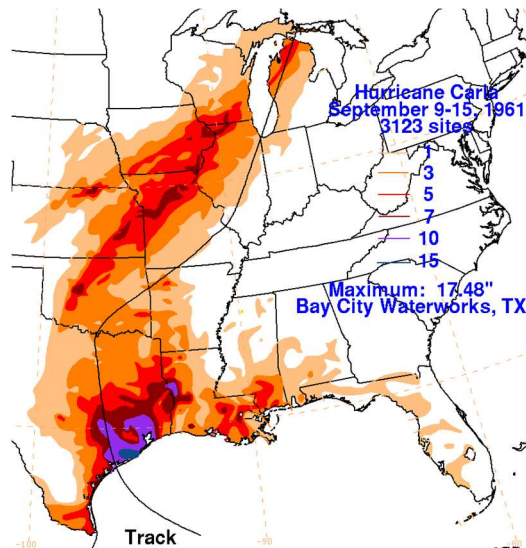
**Figure 5.05:** Path of Hurricane Carla and associated rainfall (NOAA).

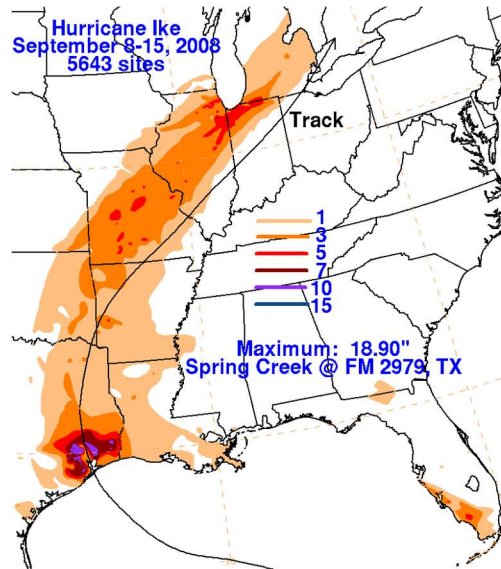
Figure 5.06: Path of Hurricane Ike and associated rainfall (NOAA).

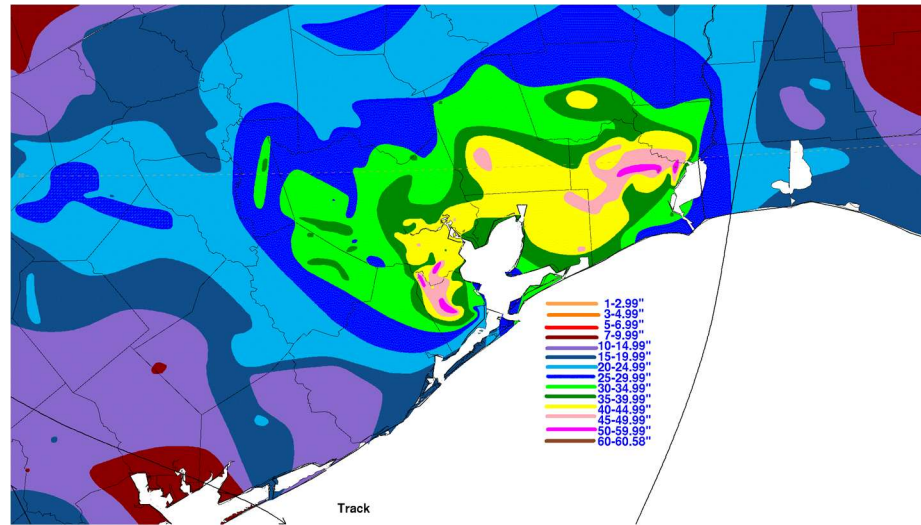
**Figure 5.07:** Path of Hurricane Harvey and associated rainfall (NOAA).

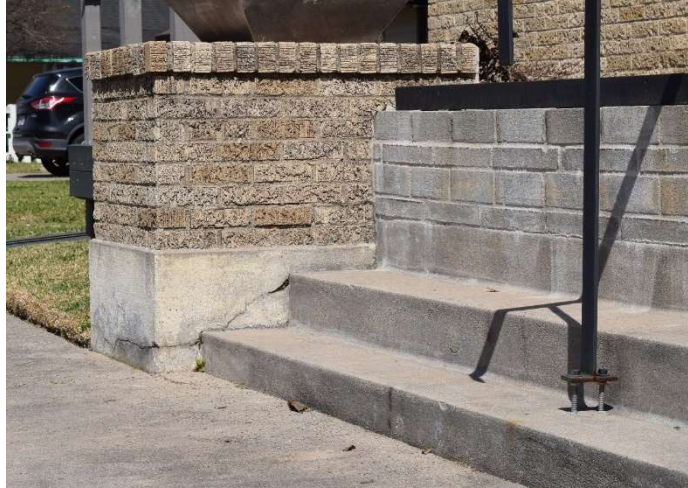
**Figure 5.08:** Cracks visible on the front stair cheek wall foundations.

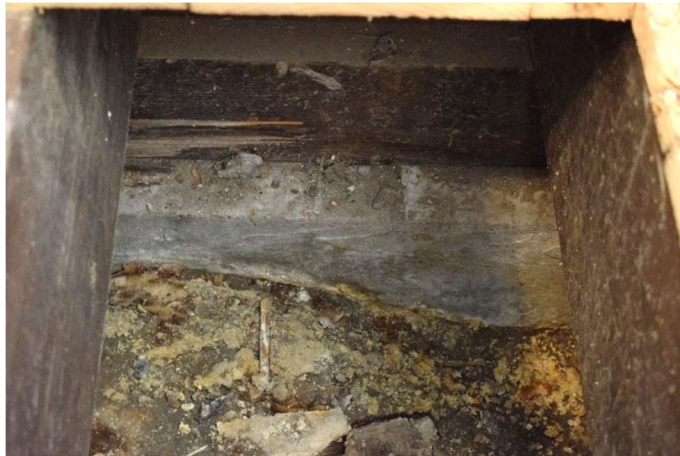
**Figure 5.09:** Perimeter beam and floor framing visible from crawl space hatch.

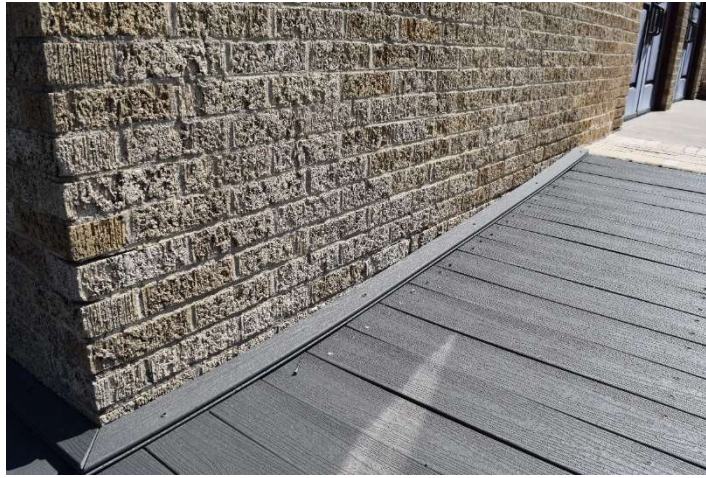
**Figure 5.10:** New exterior accessibility ramp with composite decking.

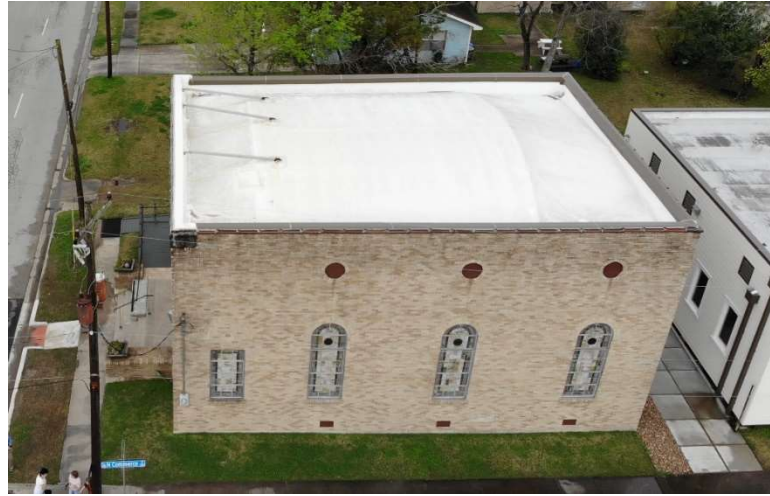
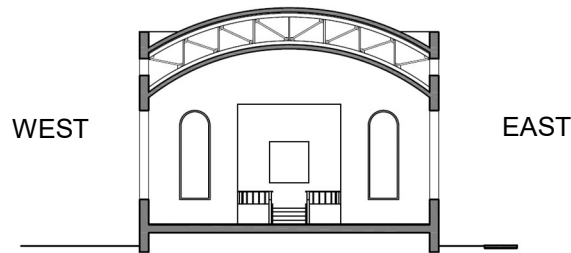
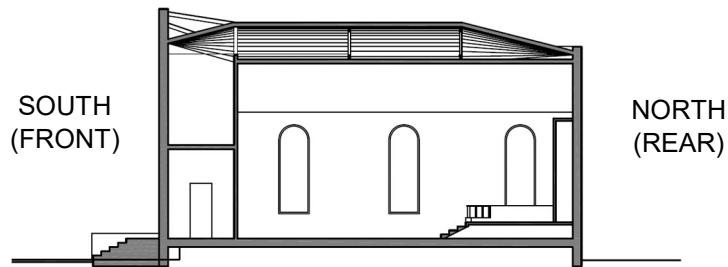
**Figures 5.11, 5.12, and 5.13:** Roof viewed from a preliminary site visit in February 2020 where standing water was observed at each corner (top). Transverse (middle) and longitudinal (bottom) drawings showing the shape of the roof.

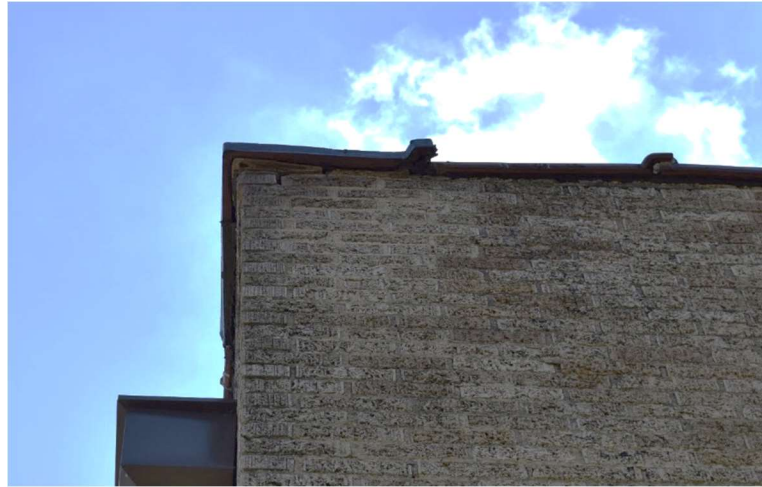
**Figure 5.14:** Coping tiles lifting up in the northwest corner due to damaged parapet. Lifting and displacement likely caused by corrosion of metal built into wall assembly.

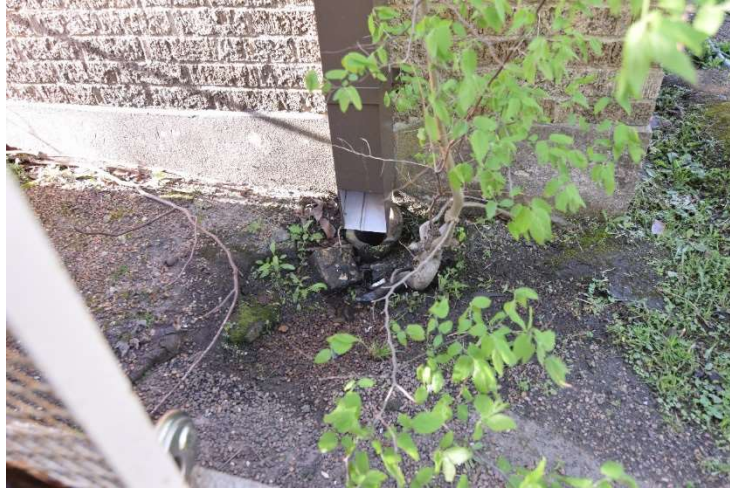
**Figure 5.15:** Downspout at the northwest corner of the building discharging partially into subgrade drainage but also directly onto the soil next to the foundation.

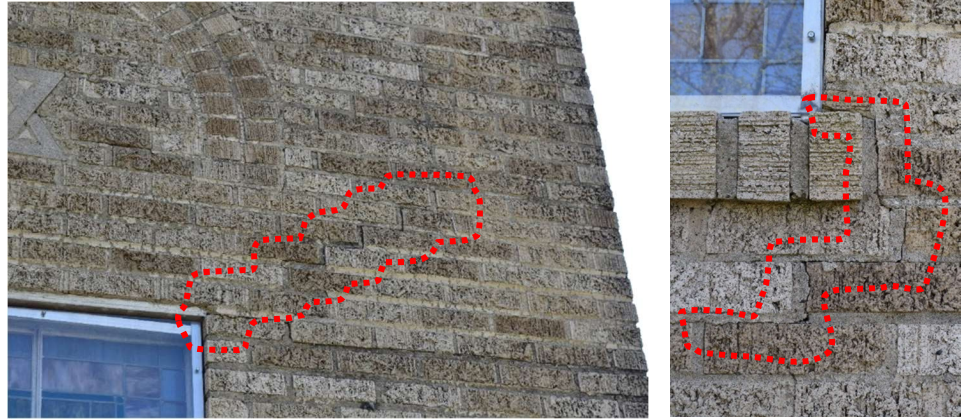
**Figures 5.16 and 5.17:** Step cracks emanating from the upper right and lower right corners of the southernmost window on the west façade.

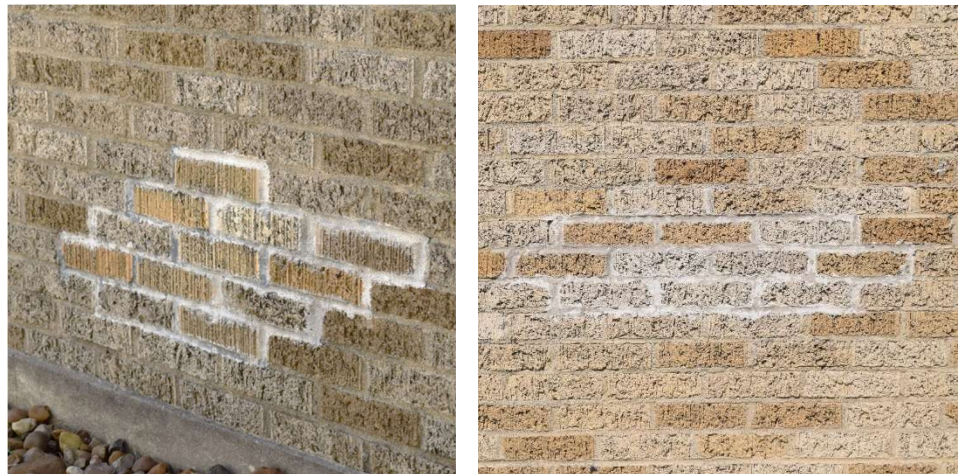
**Figures 5.18 and 5.19:** New bricks at the north wall (left) and relocated bricks on the east wall (right) taken from that location on the north wall.

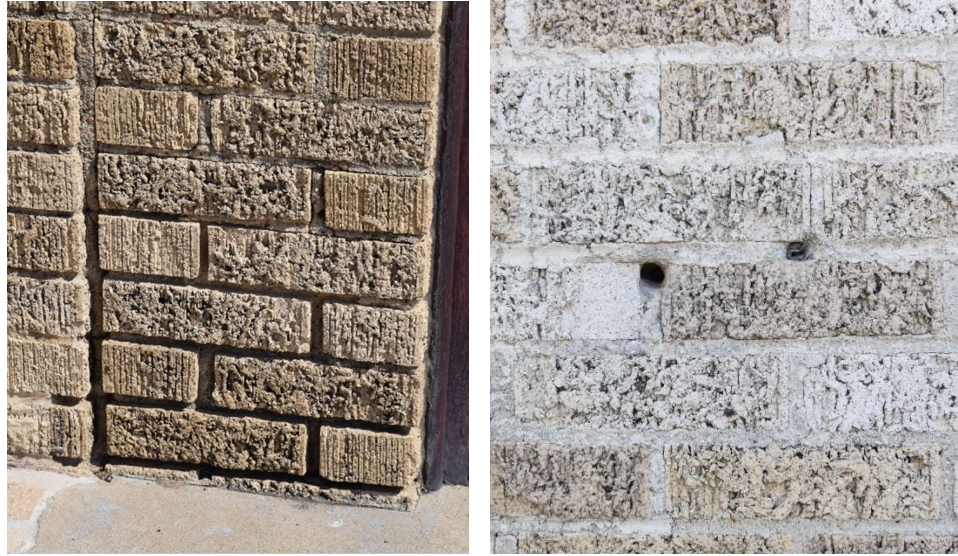
**Figures 5.20 and 5.21:** Deteriorated mortar in need of repointing. Anchor holes in the masonry on the west façade.

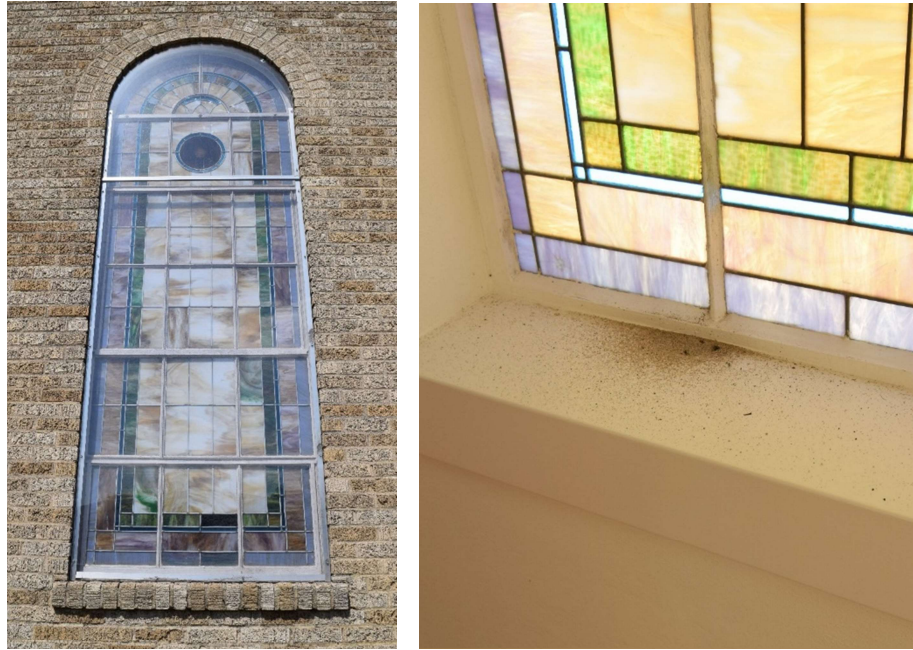
**Figures 5.22 and 5.23:** A typical sanctuary window with protective polycarbonate panel bolted to the masonry. Concentration of loose debris on window sill of the eastern window on the north wall.

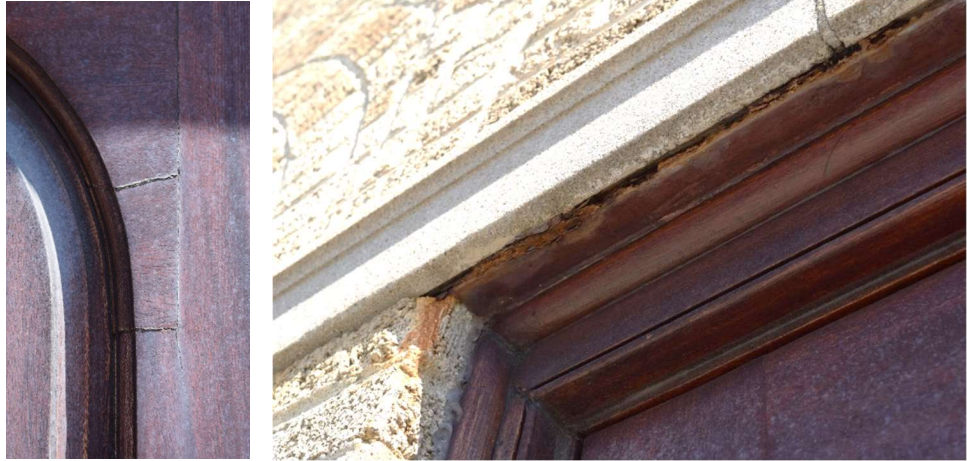
**Figures 5.24 and 5.25:** Cracked panels on the front door with no protective coating. Oxidizing steel lintel above the front doors jacking the masonry above upwards and outwards.

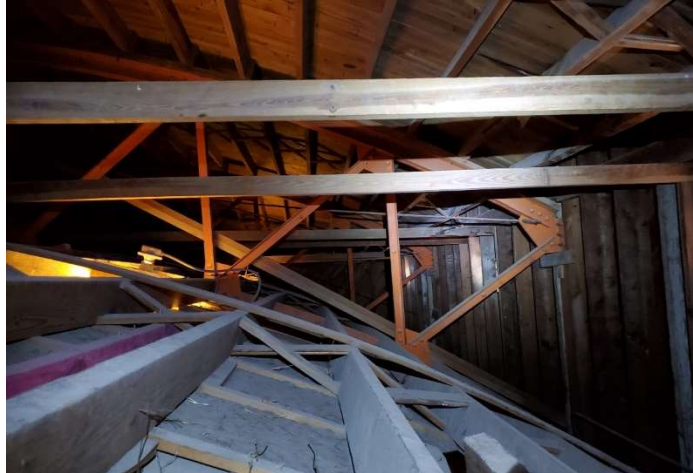
**Figure 5.26:** Steel truss and ceiling framing in good condition where observed, viewed from the southeast corner.

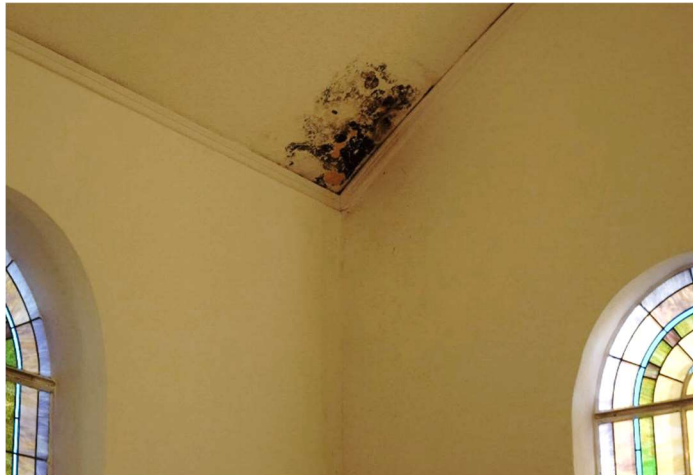
**Figure 5.27:** Water damage to ceiling and walls in northwest corner (northeast corner exhibiting similar damage).

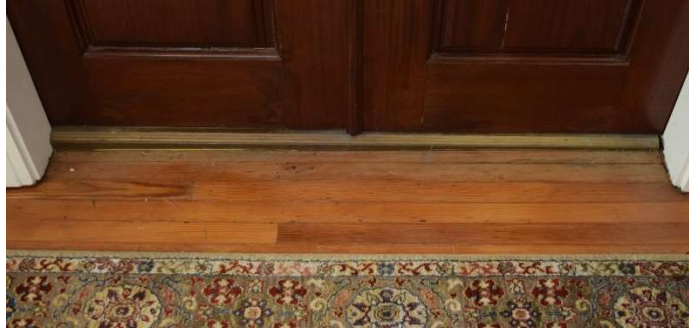
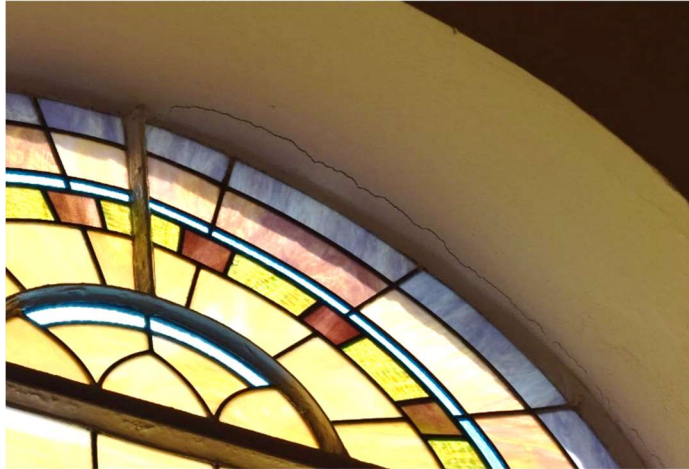
**Figures 5.28 and 5.29:** Weathered floor near the entrance threshold. Cracked plaster near a window header on the east wall.

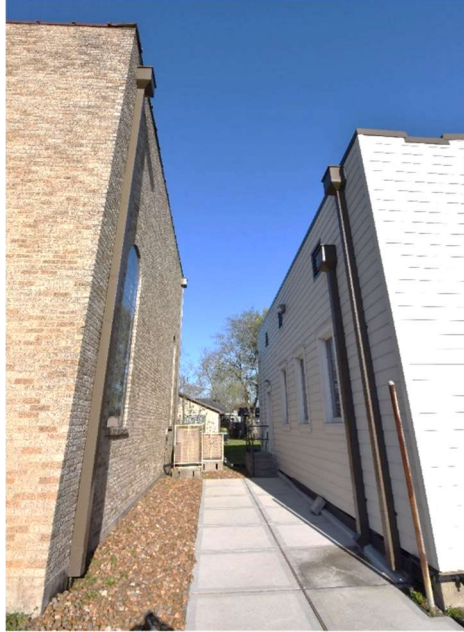
**Figure 5.30:** Area between the north end of the sanctuary and the detached hall. This area is also visible at the right of Figure 5.11.

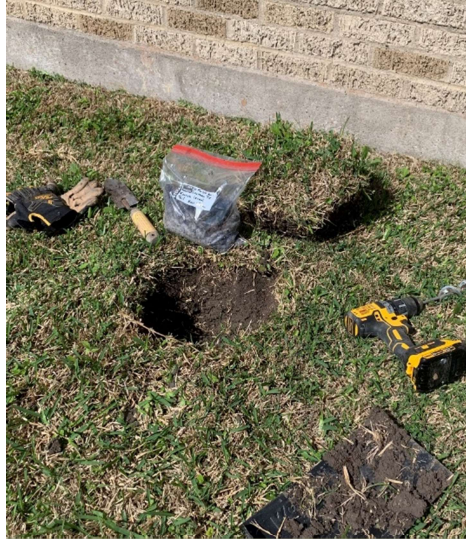
**Figure 5.31:** Soil sample collected from the east side of the sanctuary.

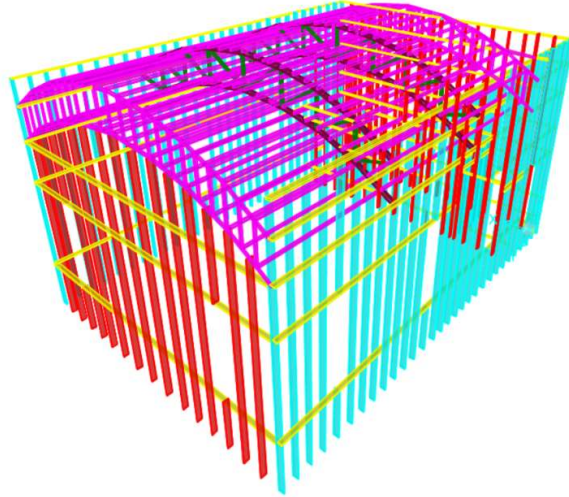
Figure 5.32: Finite element model of K'neseth Israel.

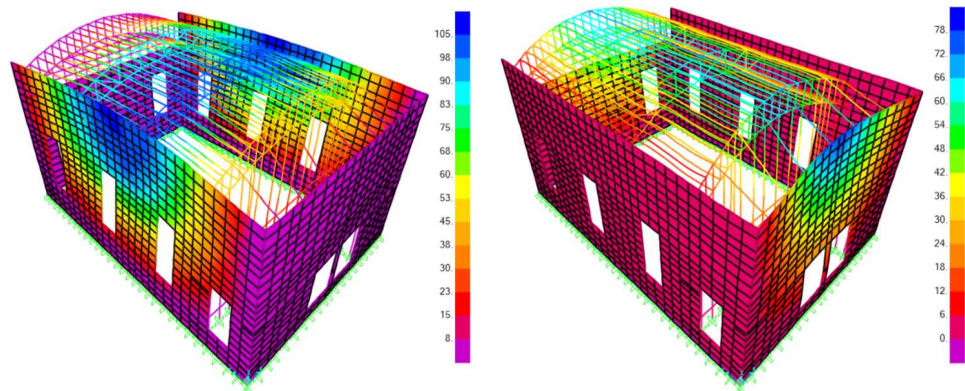
Figures 5.33 and 5.34: Deformed shape under dead and wind loads (in mm) for X direction (left) and Y direction (right).

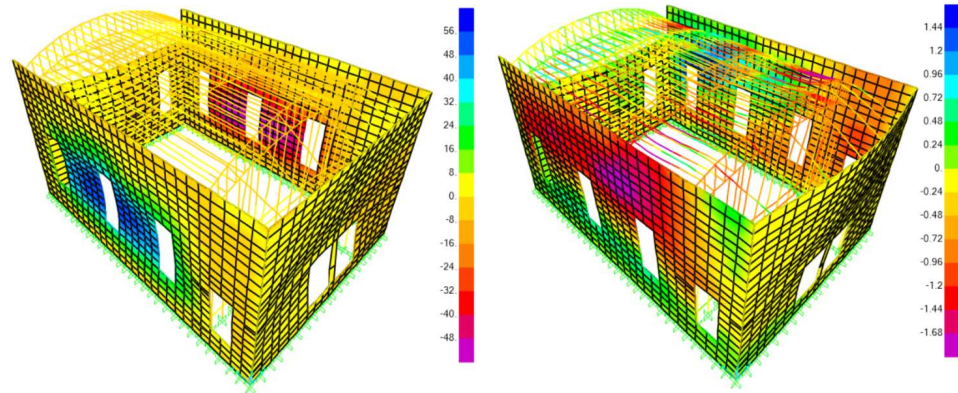
**Figures 5.35 and 5.36:** Deformed shape under extreme (left) and severe (right) flood loads (in mm).

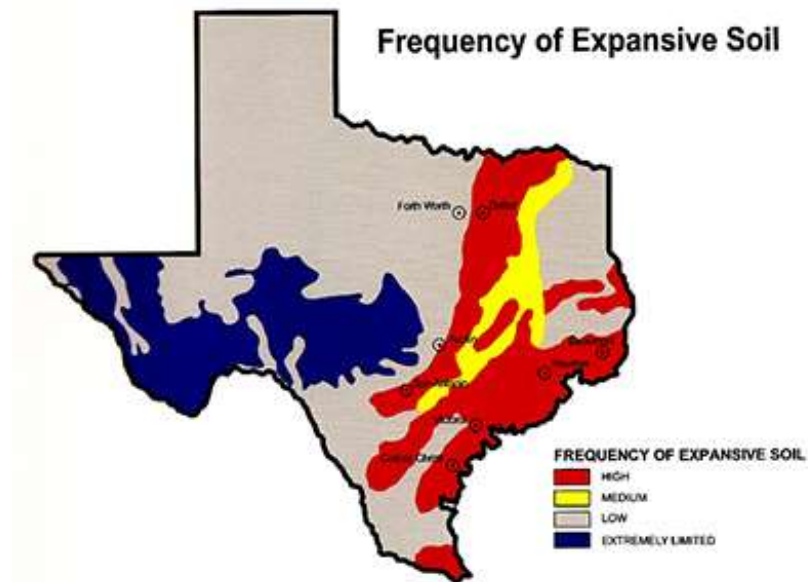
**Figure 5.B.01:** Texas expansive soil map (TxDOT).

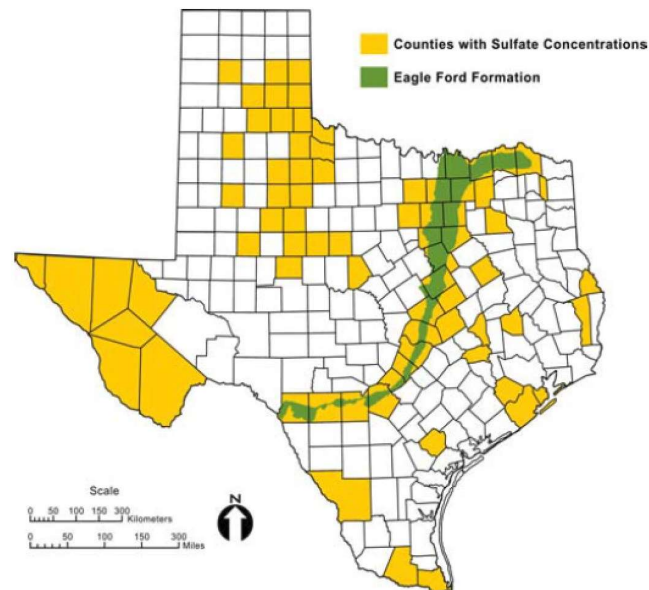
**Figure 5.B.02:** Texas sulfate soil distribution (TxDOT, 2005).

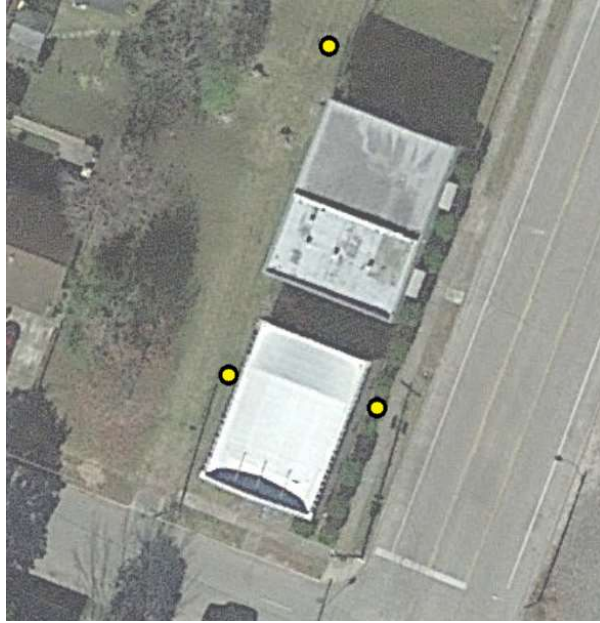
Figure 5.B.03: Map of soil sample locations.

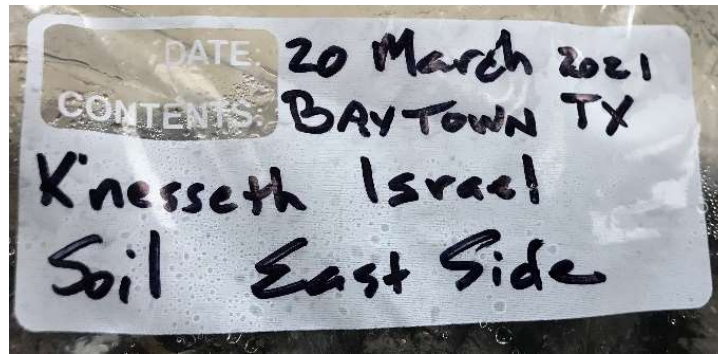
Figure 5.B.04: Soil sample from K'nesseth Israel.

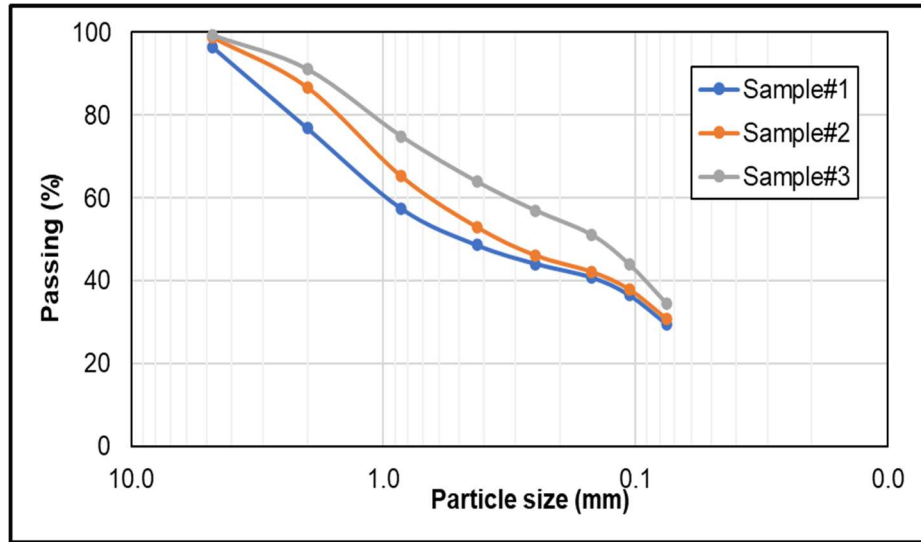
**Figure 5.B.05:** Particle size distribution of K'neseth Israel.

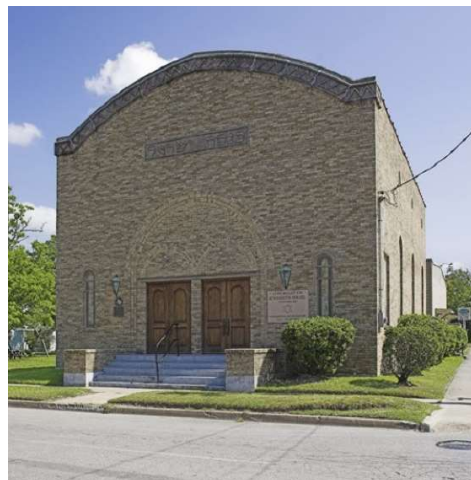
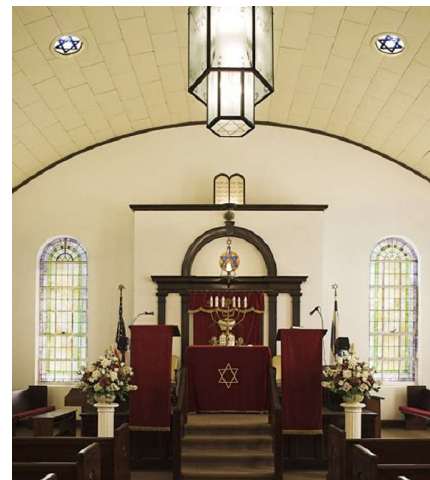
**Figures 5.C.01a and 5.C.01b:** Exterior (left) and interior (right) view of K'nesseth Israel Synagogue.

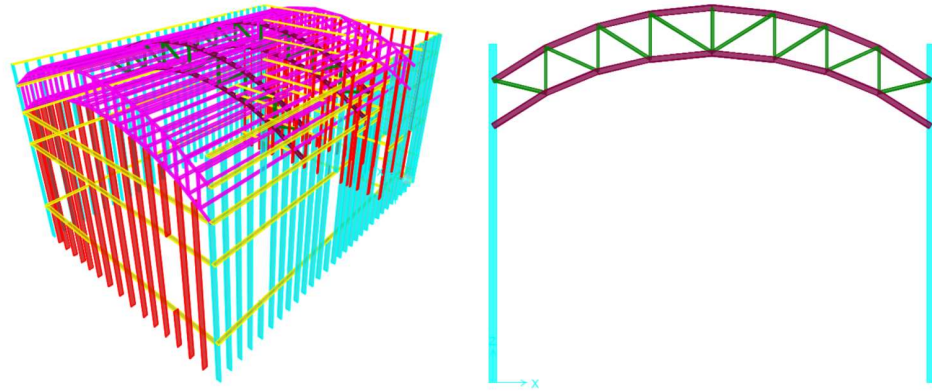
Figures 5.C.02a and 5.C.02b: 3D view (left) and truss profile (right).

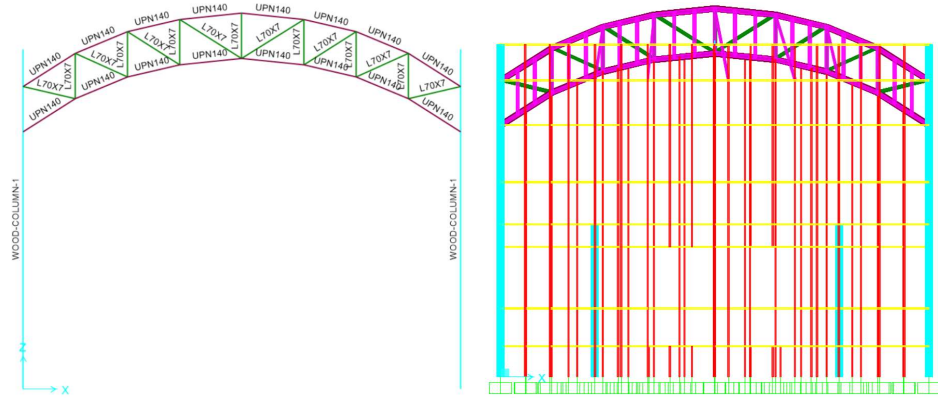
Figures 5.C.04a and 5.C.04b: Section of truss members (left) and restrain conditions (right).

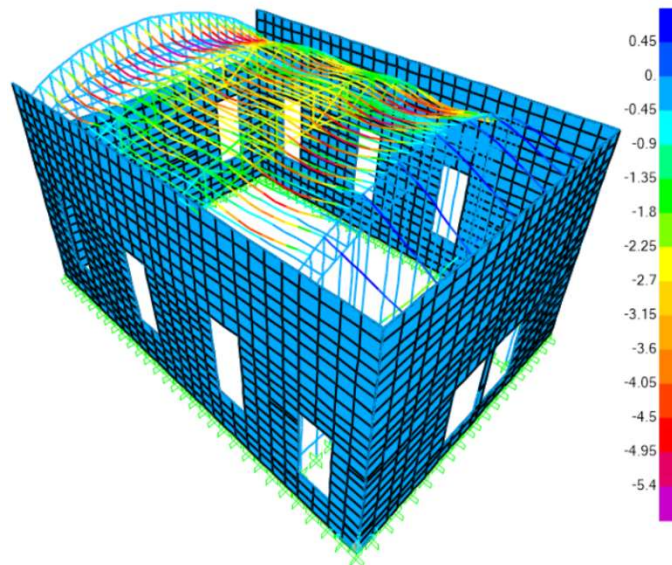
**Figure 5.C.18:** Deformed shape under dead loads.

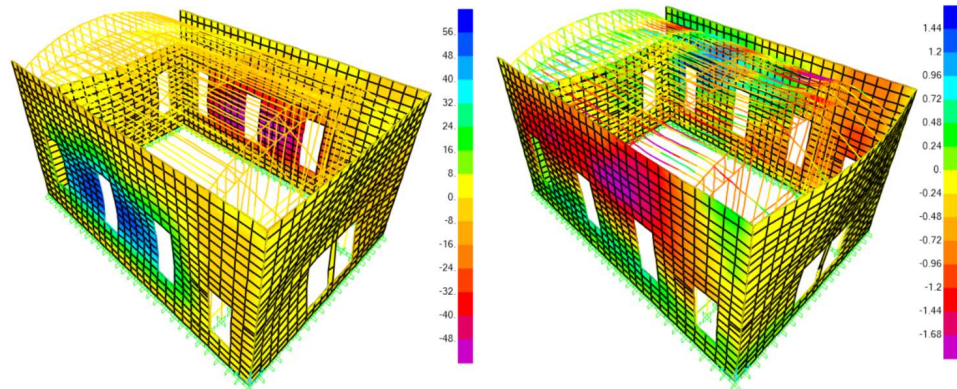
**Figures 5.C.20a and 5.C.20b:** Deformed shape under extreme (left) and severe (right) flood loads (in mm).

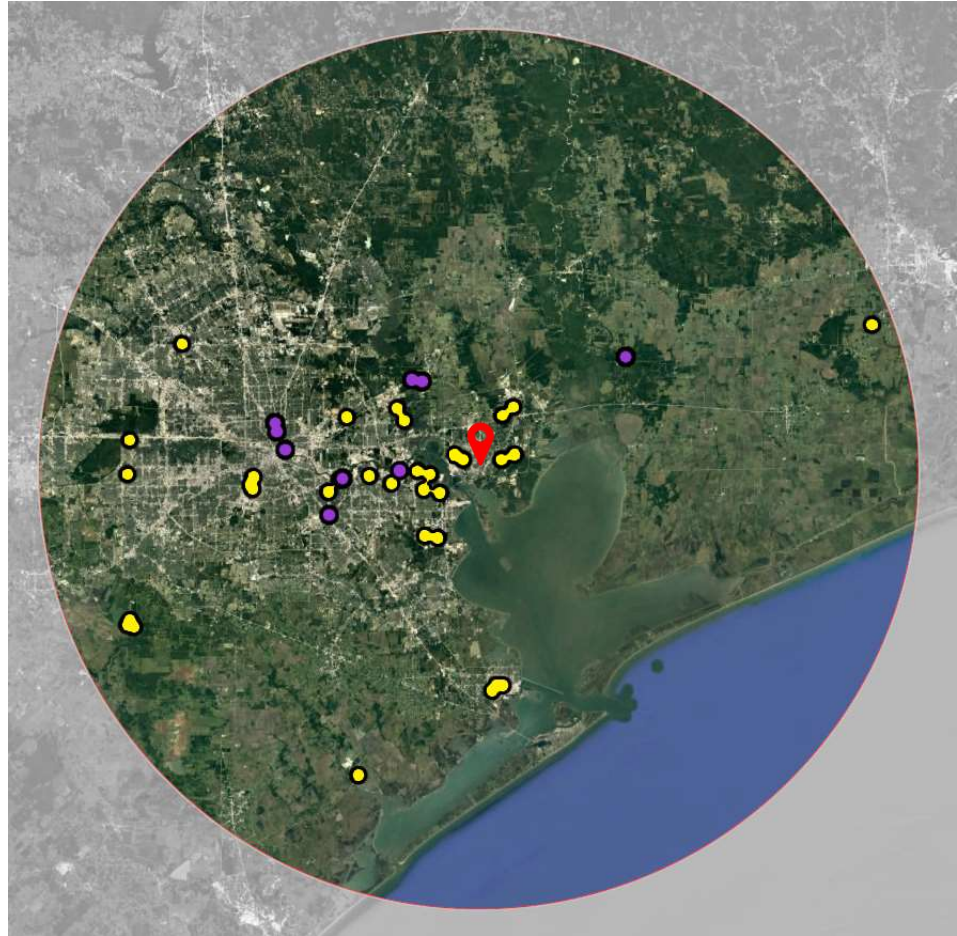
**Figure 5.D.01:** Map of environmental hazards at a regional scale. Yellow dots denote power stations (within 50 miles) and purple dots denote EPA Superfund sites on the NPL (within 25 miles).

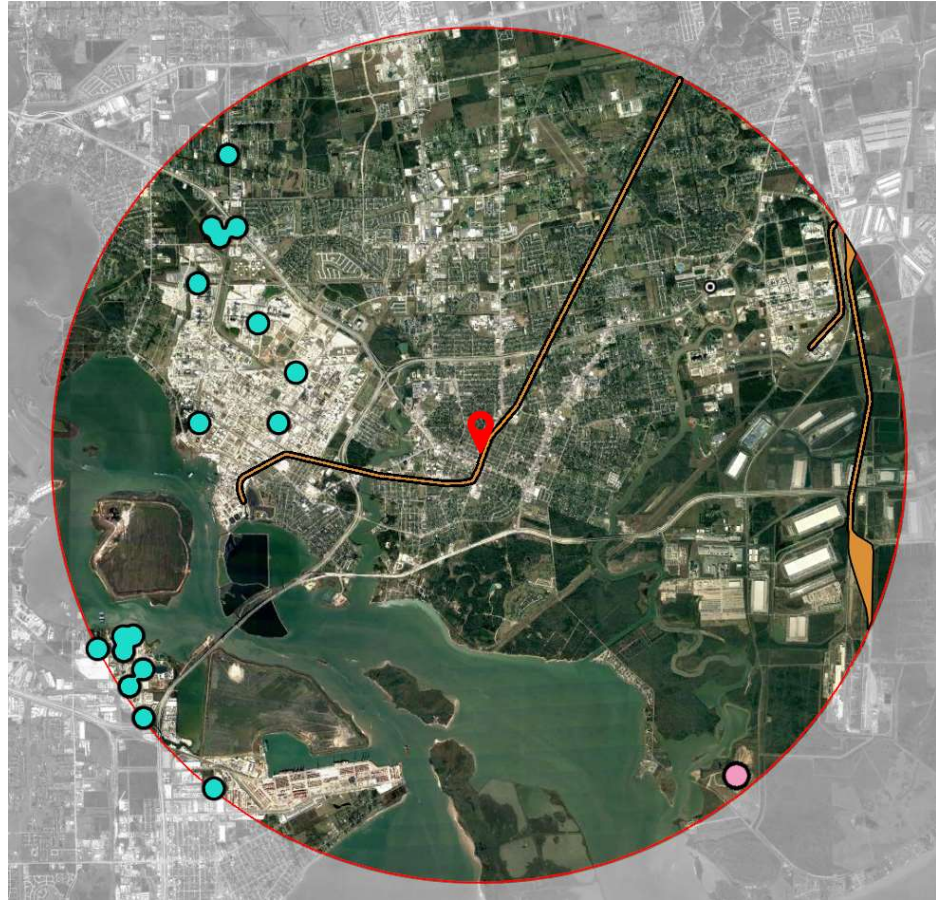
**Figure 5.D.02:** Map of environmental hazards at a neighborhood scale (within 5 miles of K'nesseth Israel). Cyan dots denote TRI industrial facilities, pink dots denote landfills, and orange lines denotes the freight rail network. Dots are located at the center of the hazard—actual boundaries may be larger or smaller than represented.

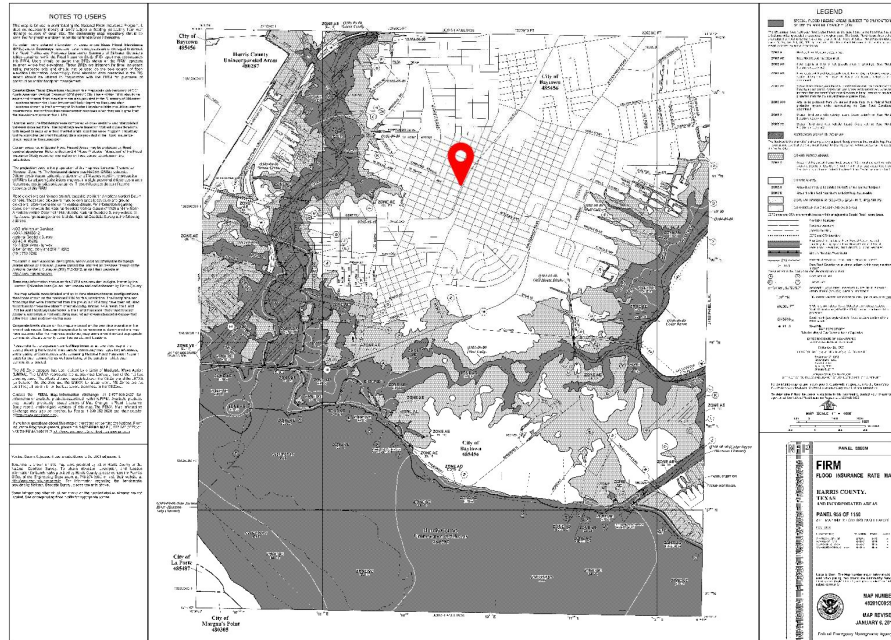
Figure 5.D.03: FEMA FIRM map number 48201C0955M with site location annotated.
